multi-engine SERVICE LETTER

ME78-2
(Supplement #1)

SUBJECT: FRONT AND REAR WING SPAR INSPECTION

ME78-2

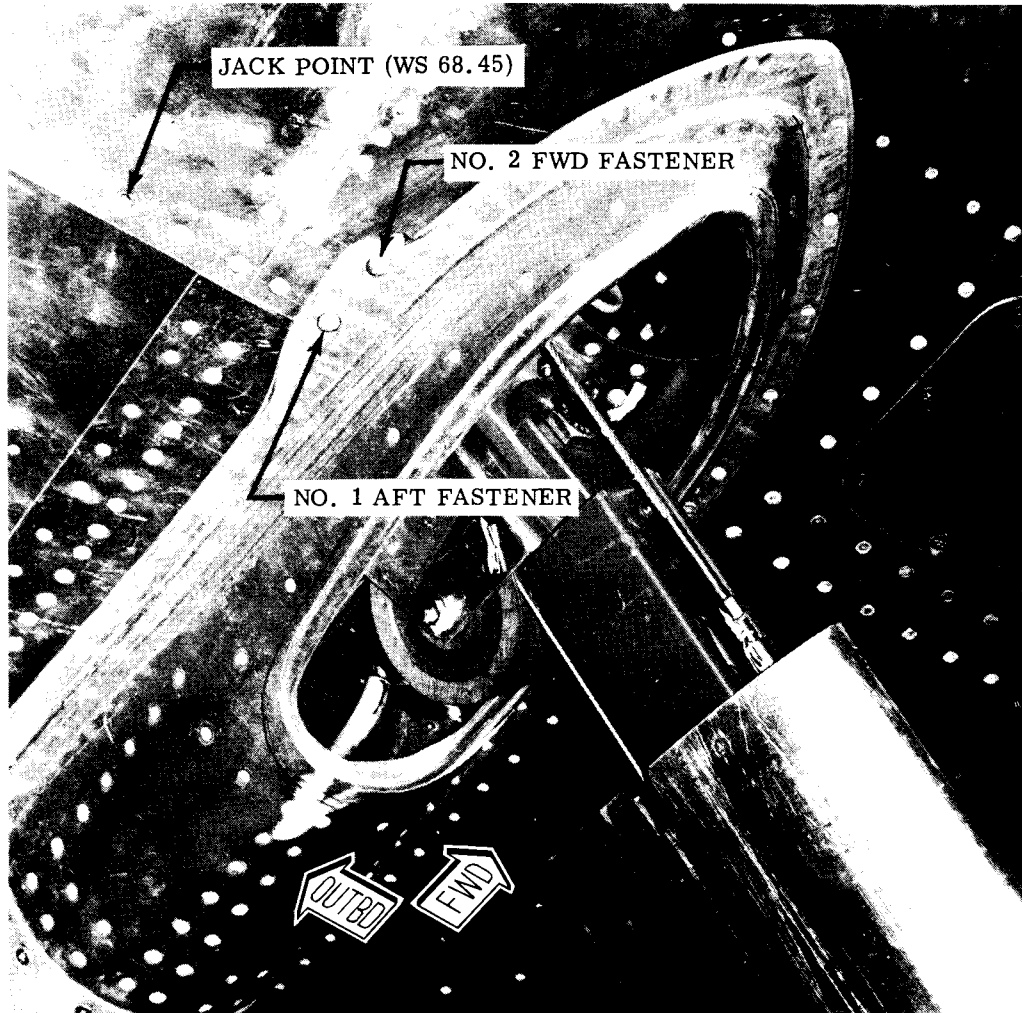
Figure 1.

The area to be inspected is immediately outboard of the wing-strut attachment. Figure 1 shows this area, two fasteners (NAS 221 screws located at Wing Station 64.41) and the Jack Point screw that must be removed for the inspection. The NAS 221 screws secure the outboard edge of the boom, the lower wing skins, a doubler plate, the horizontal flanges of the lower spar cap and angles on top of the lower spar cap. A cross section of Wing Station 64.41 with the screws removed is shown in Figure 2. A cross section of the Jack Point location (Wing Station 68.45) is shown in Figure 5.

WING STRUT ATTACHMENT AREA

WITH STRUT CUFF REMOVED

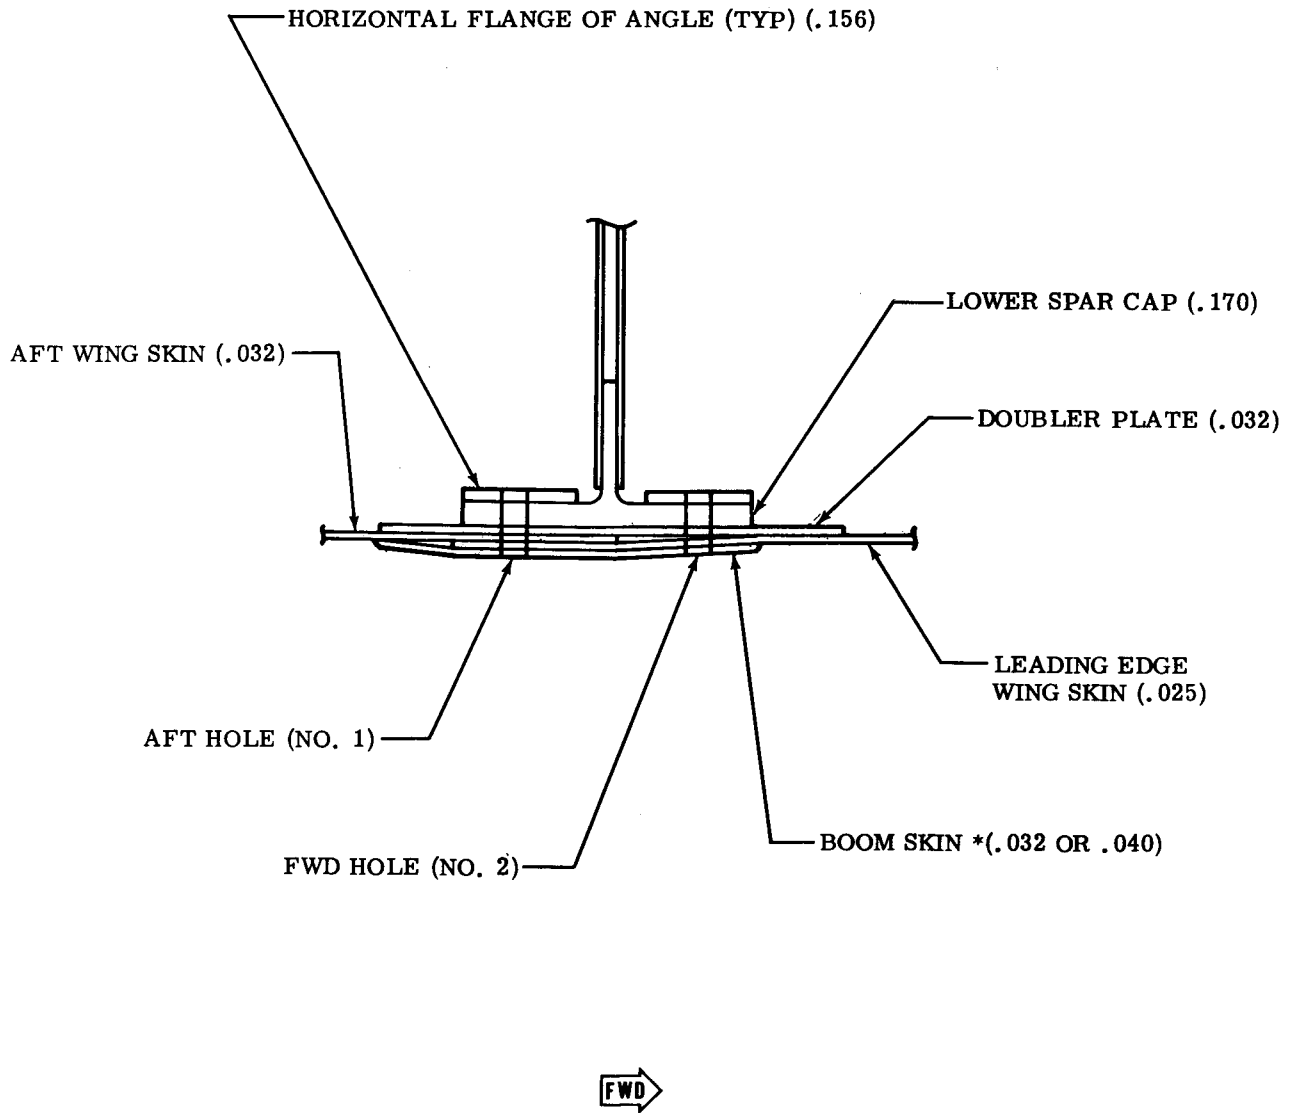
Figure 2.

LOWER SPAR CAP AT FASTENERS

WING STATION 64.41

*.032 THRU SERIAL 337-0755
.040 SERIAL 337-0756 & ON

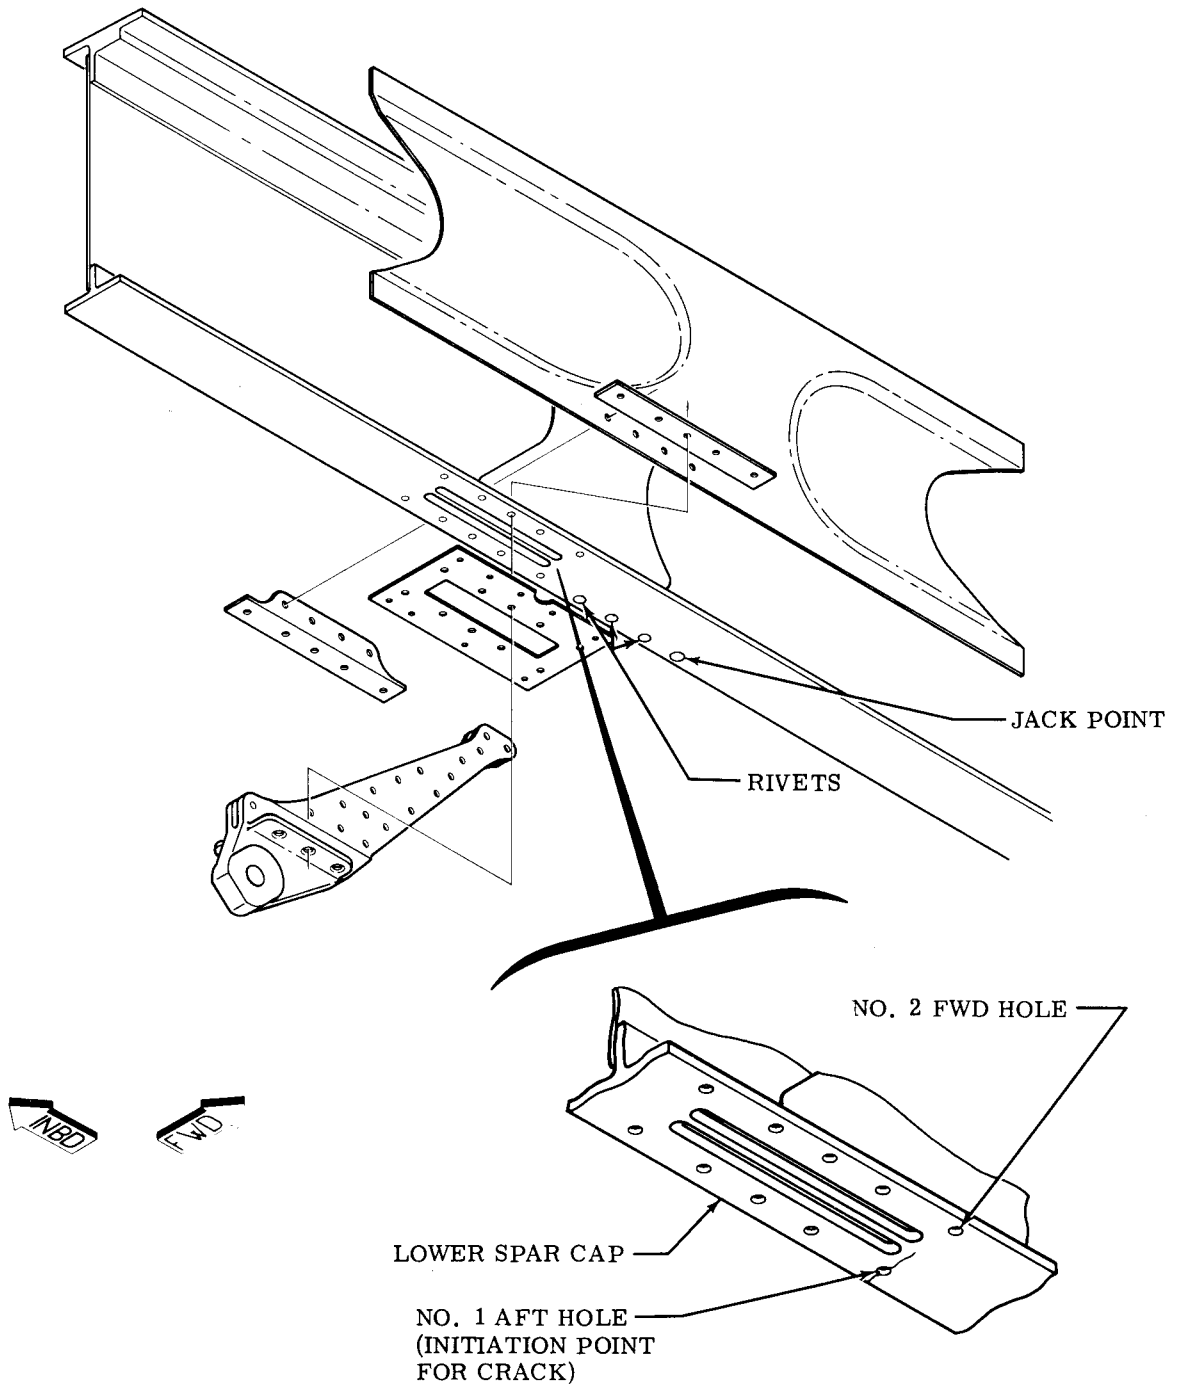
The lower spar cap is a T-section and the material is 2014-T6 or 2014-T6511, depending on the year the aircraft was manufactured. An exploded view of the spar assembly (less boom and wing skins) shows the relationship of the lower cap to the other parts at the strut attachment in Figure 3. Also shown in this figure is the initiation point for the crack mentioned in Service Letter ME72-26.

FRONT WING SPAR-BOOM & STRUT ATTACHMENT AREA

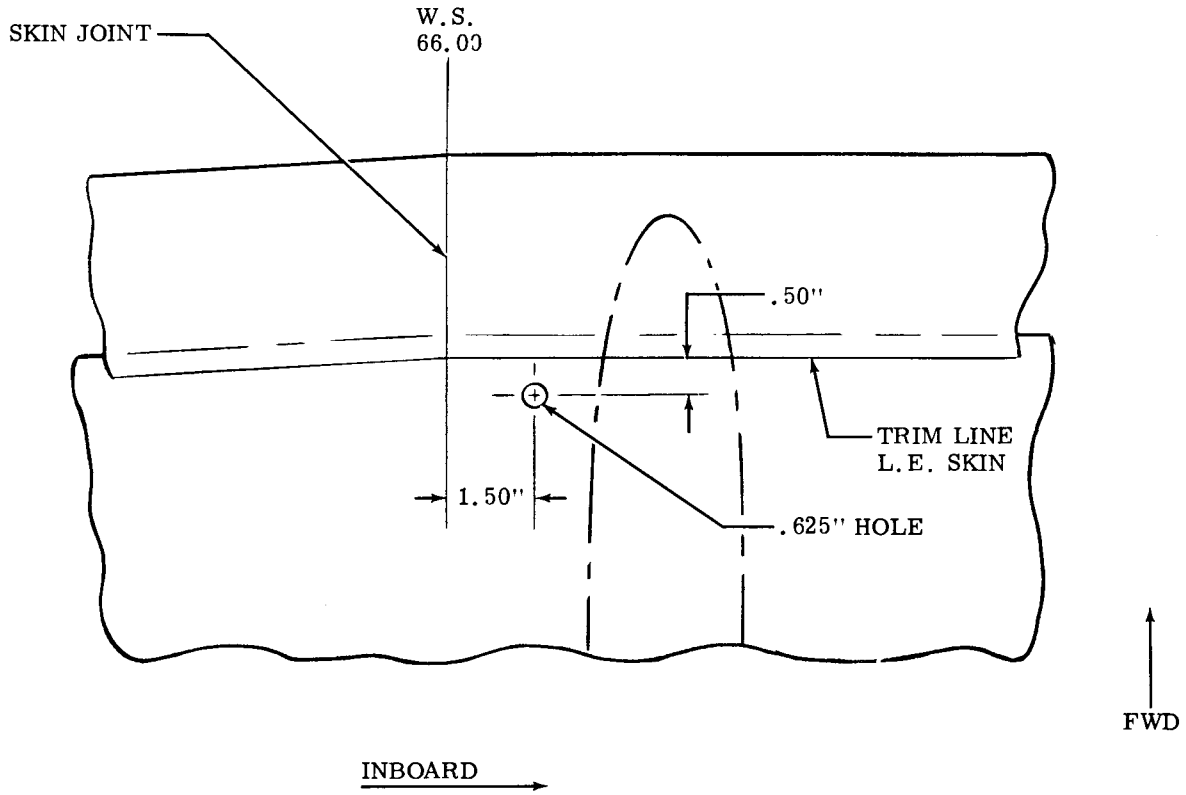
1. Remove wing strut fairings.
2. Remove upper wing strut cuffs.
3. Drill a .625 inch hole in the upper wing skins outboard of the booms as shown in Figure 4. Before drilling, make certain that the hole location is centered as far away from stringers, rib flanges and spar flanges as possible. The hole must not be drilled through any of these. After drilling, the edge of the hole must be polished to remove any defects from which cracks could initiate.

ADDITION OF ACCESS HOLE FOR NO. 1 AFT FASTENER

- After the inspection has been completed, a .625 inch plug button must be installed in the hole and sealer added around the hole to prevent moisture from entering the wing through this hole.
- The area around the hole should be carefully inspected (visually) at each 100 hour and/or annual inspection period to assure that if any skin cracking occurs, it will be caught at an early stage.

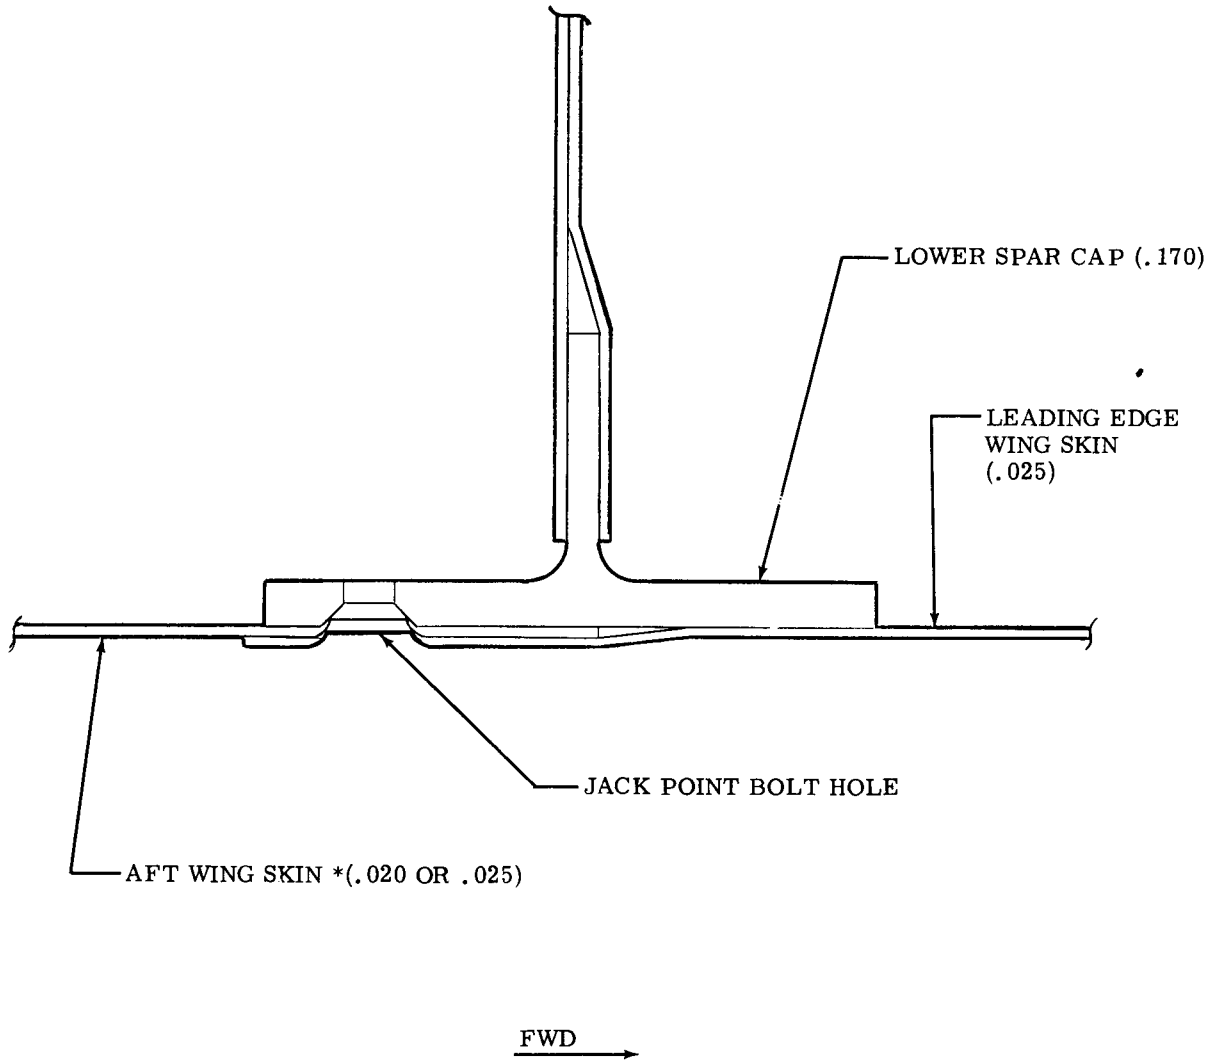
Figure 5.

LOWER SPAR CAP AT JACK POINT

WING STATION 68.45

*.020 THRU SERIAL 337-0755
.025 SERIAL 337-0756 & ON

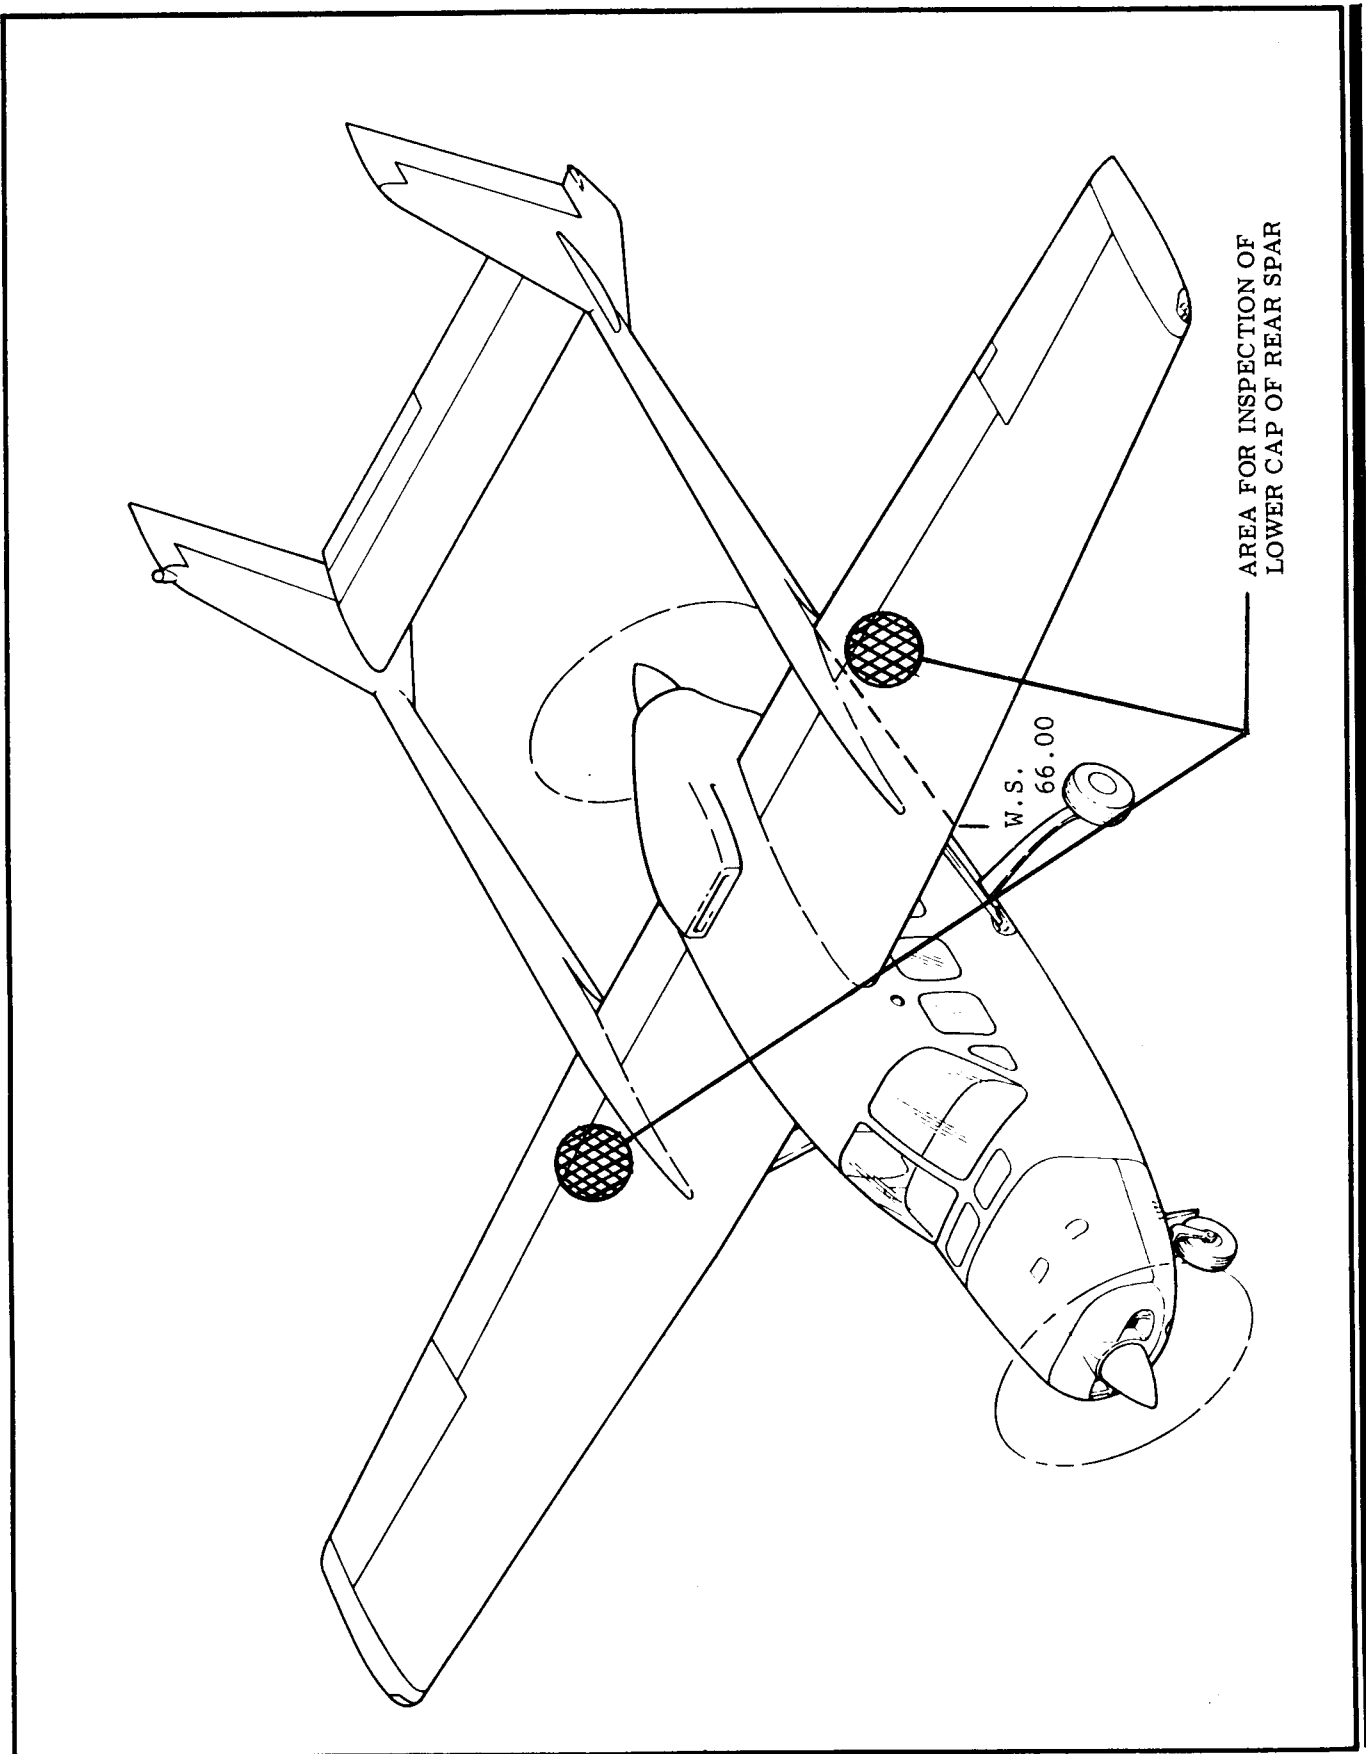
1. Dye penetrant inspect lower spar cap over an area ranging from 2 to 3 inches outboard of the Wing Station 66.00 rib. (Refer to figures 6, 7 and 8)

Figure 6. Rear Spar Lower Cap Inspection.

In the event that cracks are found in either the front or rear spar caps, the respective spar caps in both the left and right wing must be replaced.

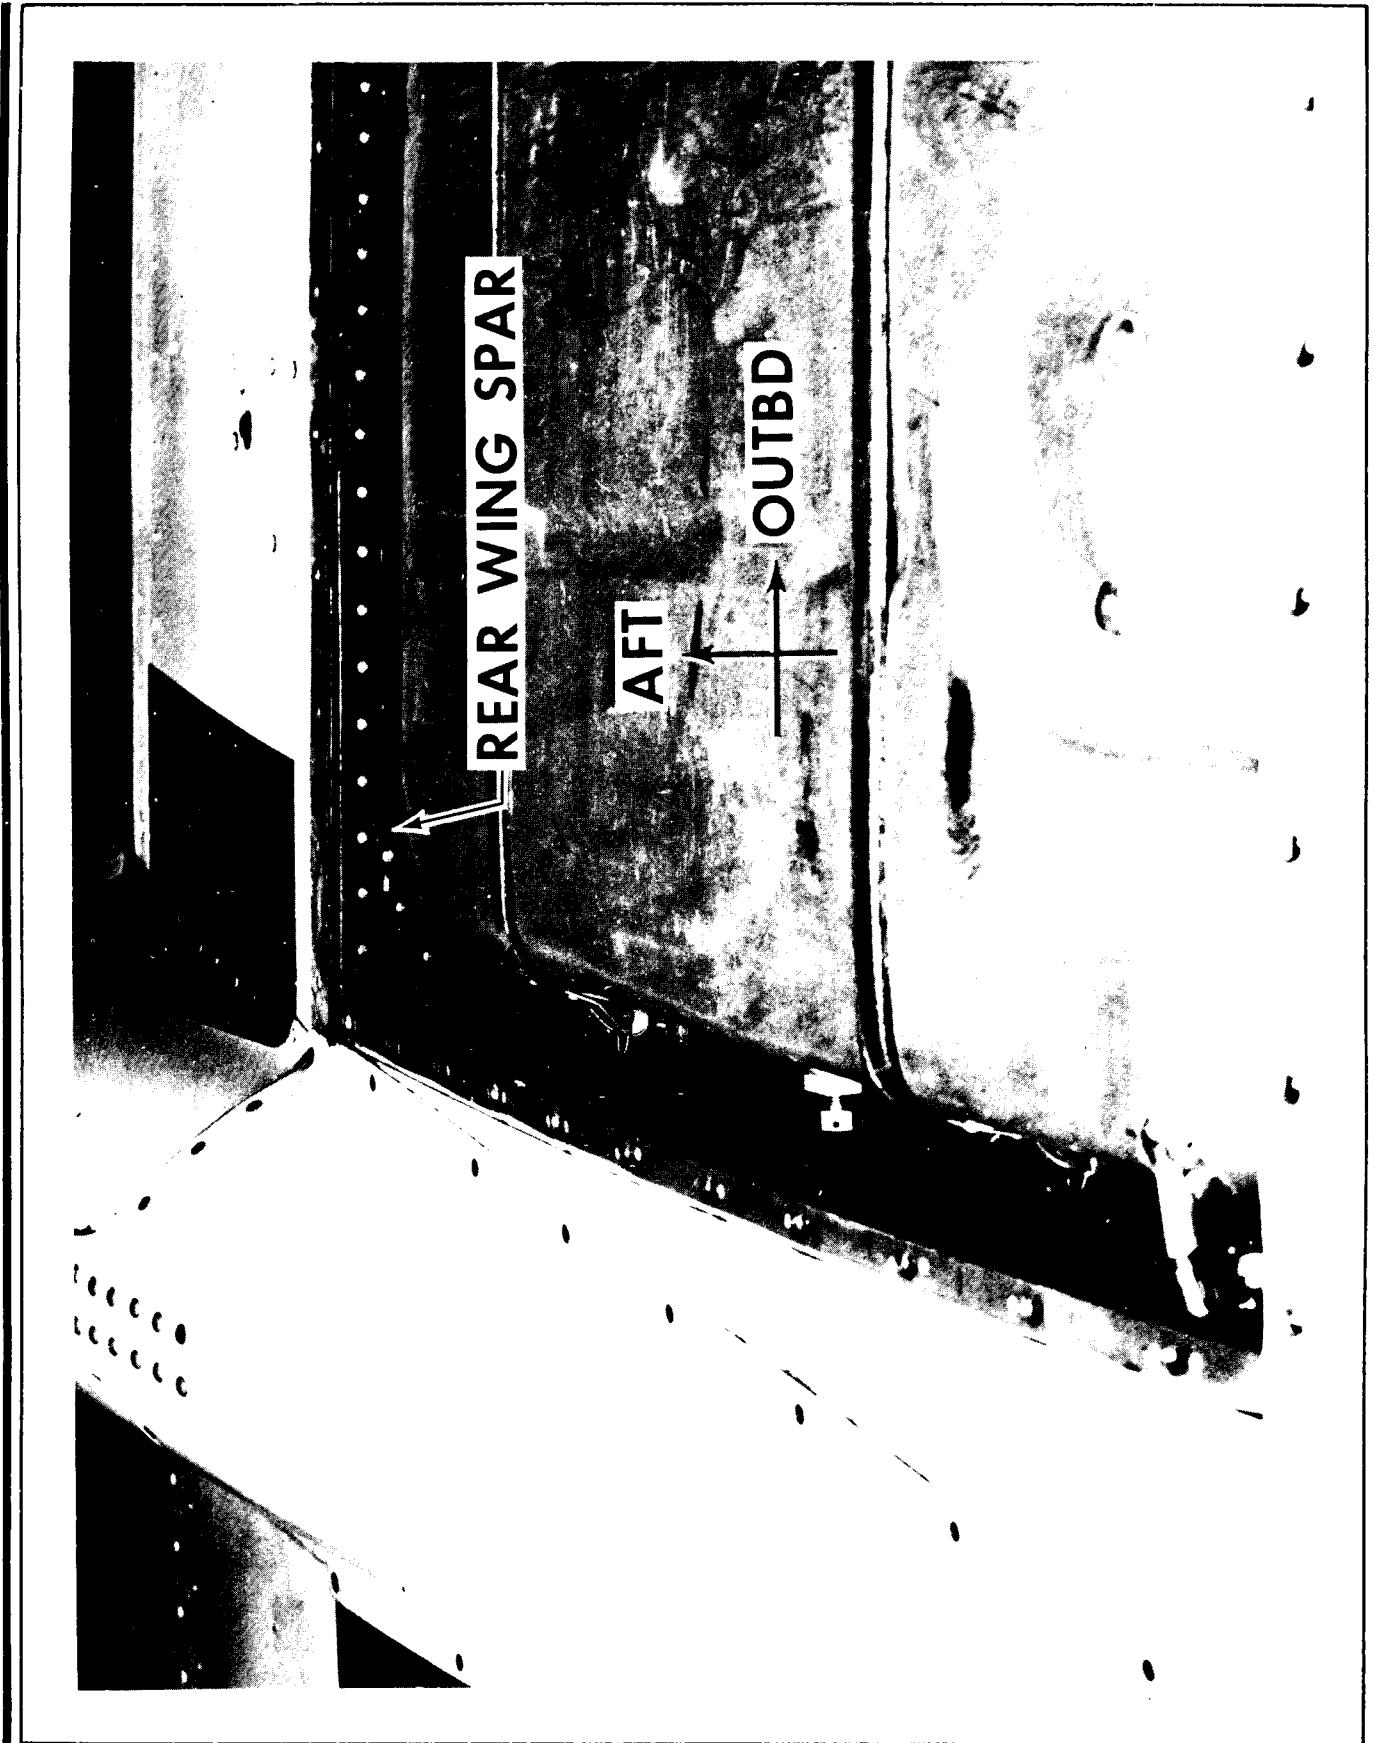
Figure 7. Left Rear Wing Spar. (fuel tank cover removed)

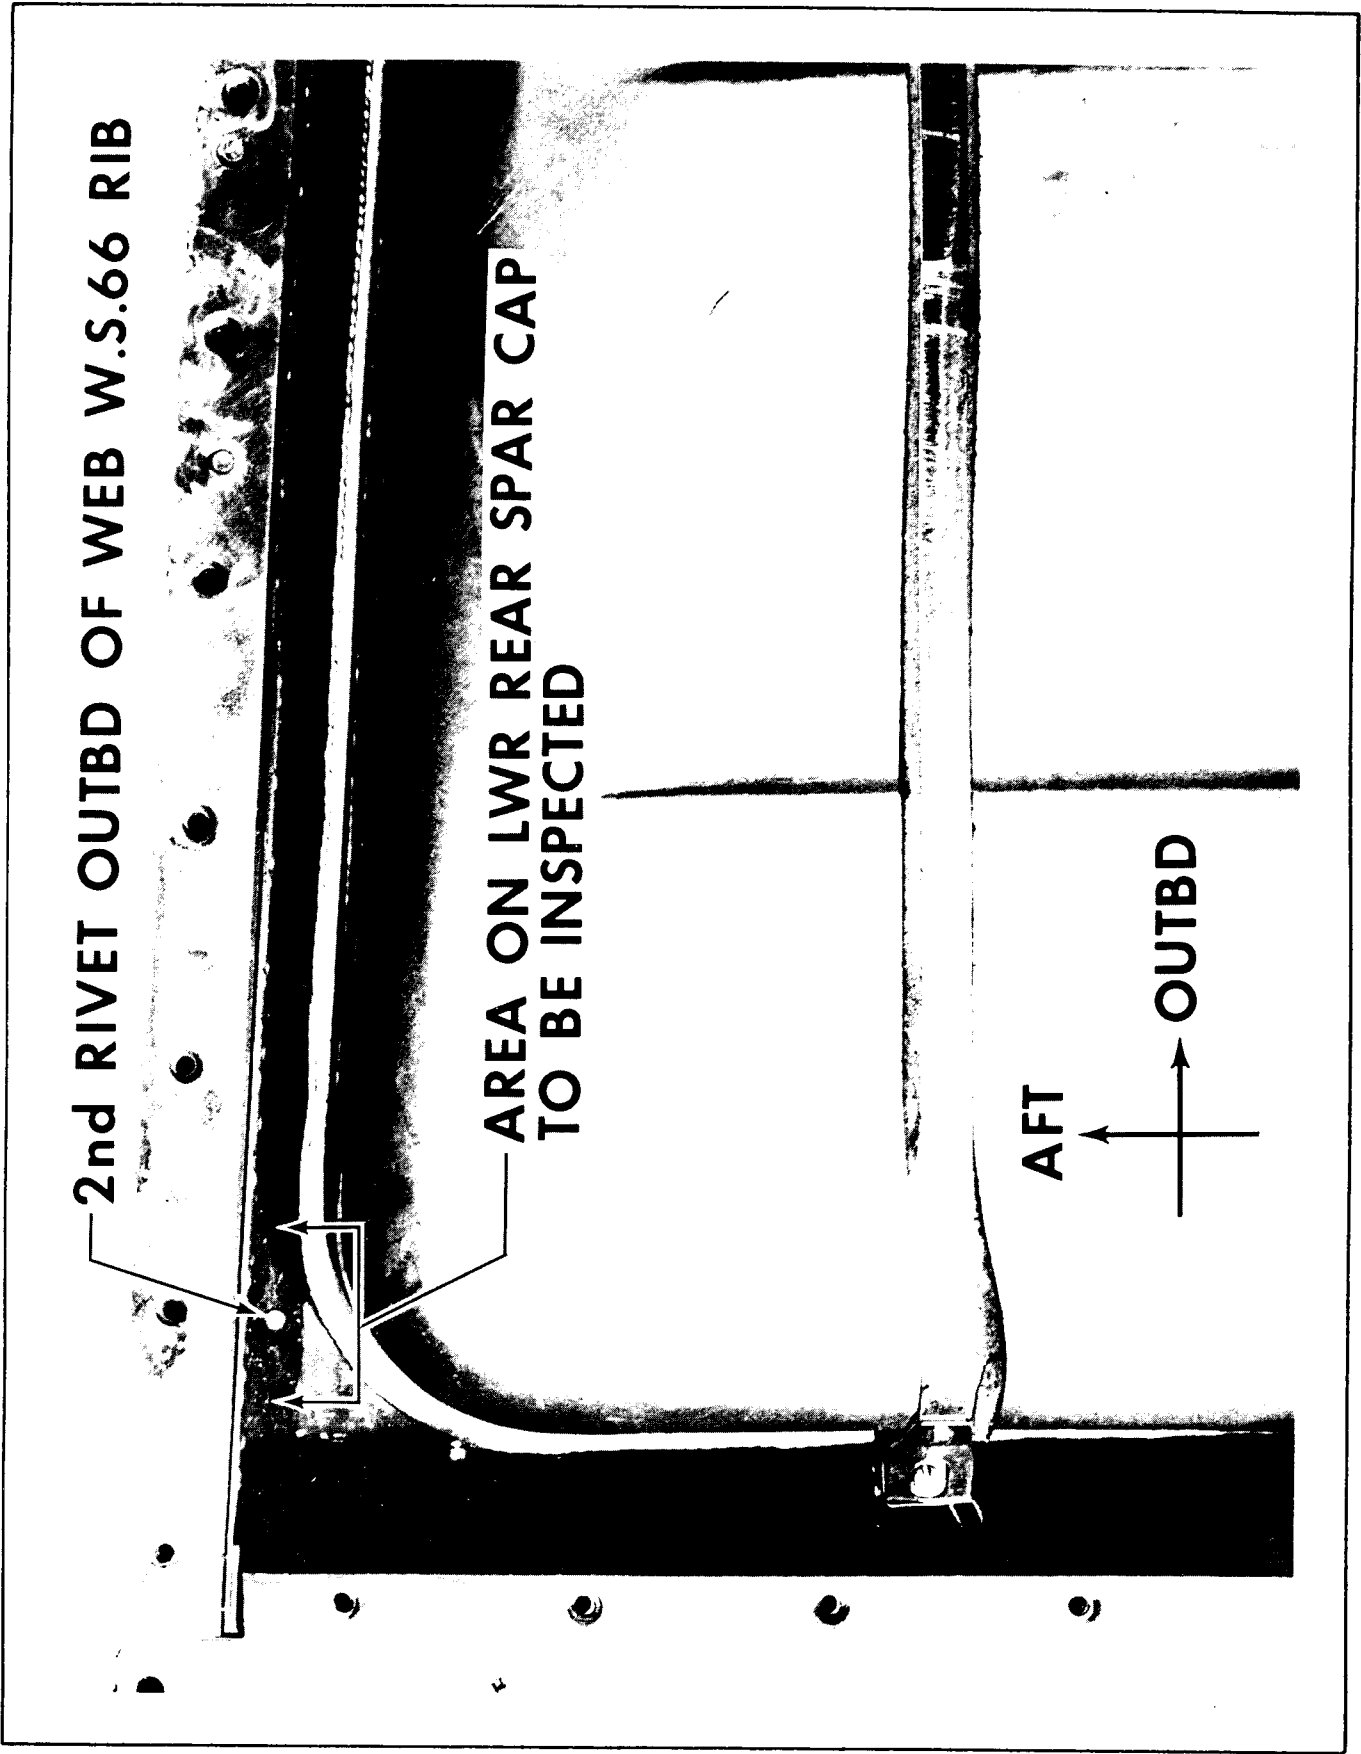
Figure 8. Inspection Area.

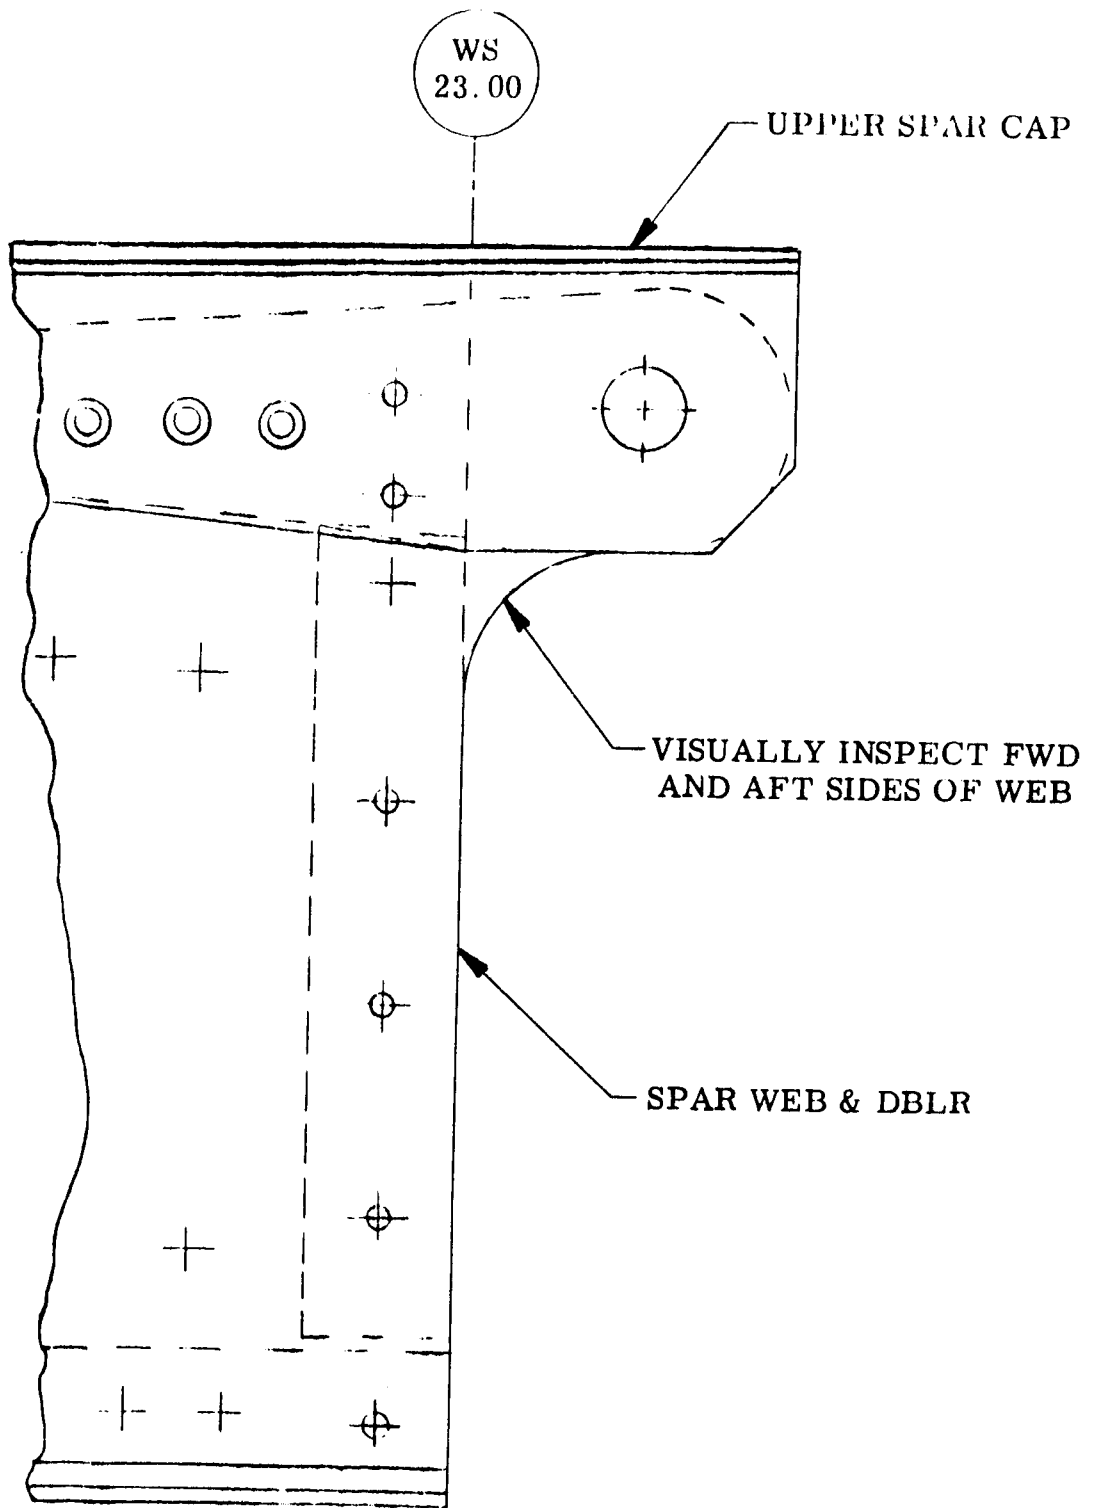
FIGURE 9

- 3) Figure 9 of the inspection instructions has been revised to include more detail of the front spar inboard end (attached).

1. Visually inspect the radii of both the spar web and the web doubler in the shaded area as shown in Figure 9.

As a result of recent field experience, an inspection of the radius in the web of the front spar just below the attach fitting needs to be added to this total program. This inspection applies to all of the airplanes included in the previous inspection plus additional ones as indicated above under AIRCRAFT APPLICABILITY, Front Spar Web. This inspection is relatively simple, consisting of a visual inspection of the wing spar attachment web and web doubler.

The Model 337 front wing spar web and web doubler were redesigned to provide a larger radius to lessen the likelihood of cracks initiating in this area. These improvements were incorporated on production aircraft in 1977 at the following serial numbers.

In the event that cracks are found in the spar web and web doubler, these parts must be replaced.
