[Docket No. FAA-2010-1013; Directorate Identifier 2010-CE-048-AD; Amendment 39-16478; AD 2010-21-18]

Airworthiness Directives; Cessna Aircraft Company (Cessna) Models 336, 337, 337A (USAF 02B), 337B, M337B (USAF 02A), T337B, 337C, T337C, 337D, T337D, 337E, T337E, 337F, T337F, 337G, T337G, 337H, P337H, T337H, T337H-SP, F337E, FT337E, F337F, FT337F, F337G, FT337GP, F337H, and FT337HP Airplanes

2010-21-18 Cessna Aircraft Company: Amendment 39-16478; Docket No. FAA-2010-1013; Directorate Identifier 2010-CE-048-AD.

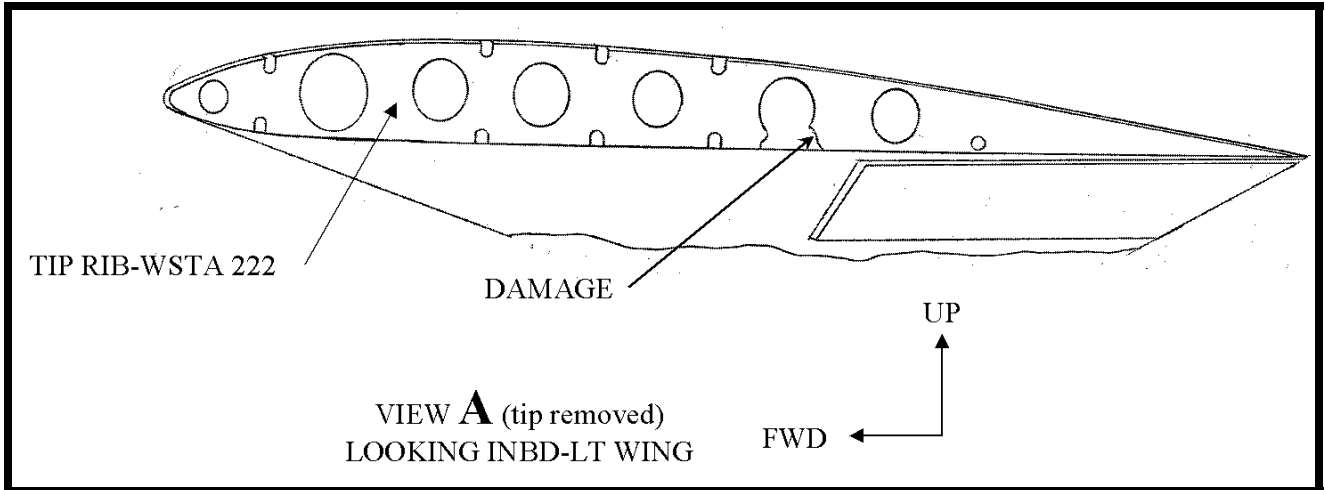
Figure 2

Further inspection revealed additional damage on the airplane that appeared to be a result of the installation of the wing extension modification. There was damage to the left and right WSTA 222 ribs, which had been torn, from the aft lightening hole to the lower surface and was bent down to allow installation of the wing extension fuel line. The fuel line appeared to be chafing on the torn metal. Also, extra holes drilled through the spar cap were found at several span-wise locations that were consistent with the stall fence attachments. These holes had been tapped (threaded) and were left open with no fastener installed. One of the holes was located so close to the edge of the spar cap, it was breaking out of the edge and was also located immediately adjacent to a fastener for the fuel tank access cover. Also found was the lack of nuts used for the wing extension attaching screws. It appeared that the holes in the substructure (skins, ribs, and spars) were tapped (threaded) to accept screws, rather than use nuts. Several access holes were also found cut into the lower surface of the skin that had no reinforcement.

- (10) Inter-rivet buckling of the stringers attached to the upper surface skin, outboard of the fuel tank access covers (See View F, Figure 7).
- (11) Inspect rib at WSTA 222 for damage. Trimming of the rib may have been done to allow installation of fuel lines (See View A, Figure 2). Repair in accordance with AC 43.13-1B, Chapter 4, paragraph 4-58(g) and Figure 4-14, or by using another FAA-approved method that restores equivalent strength of the wing rib.

Repair torn WSTA 222 Rib

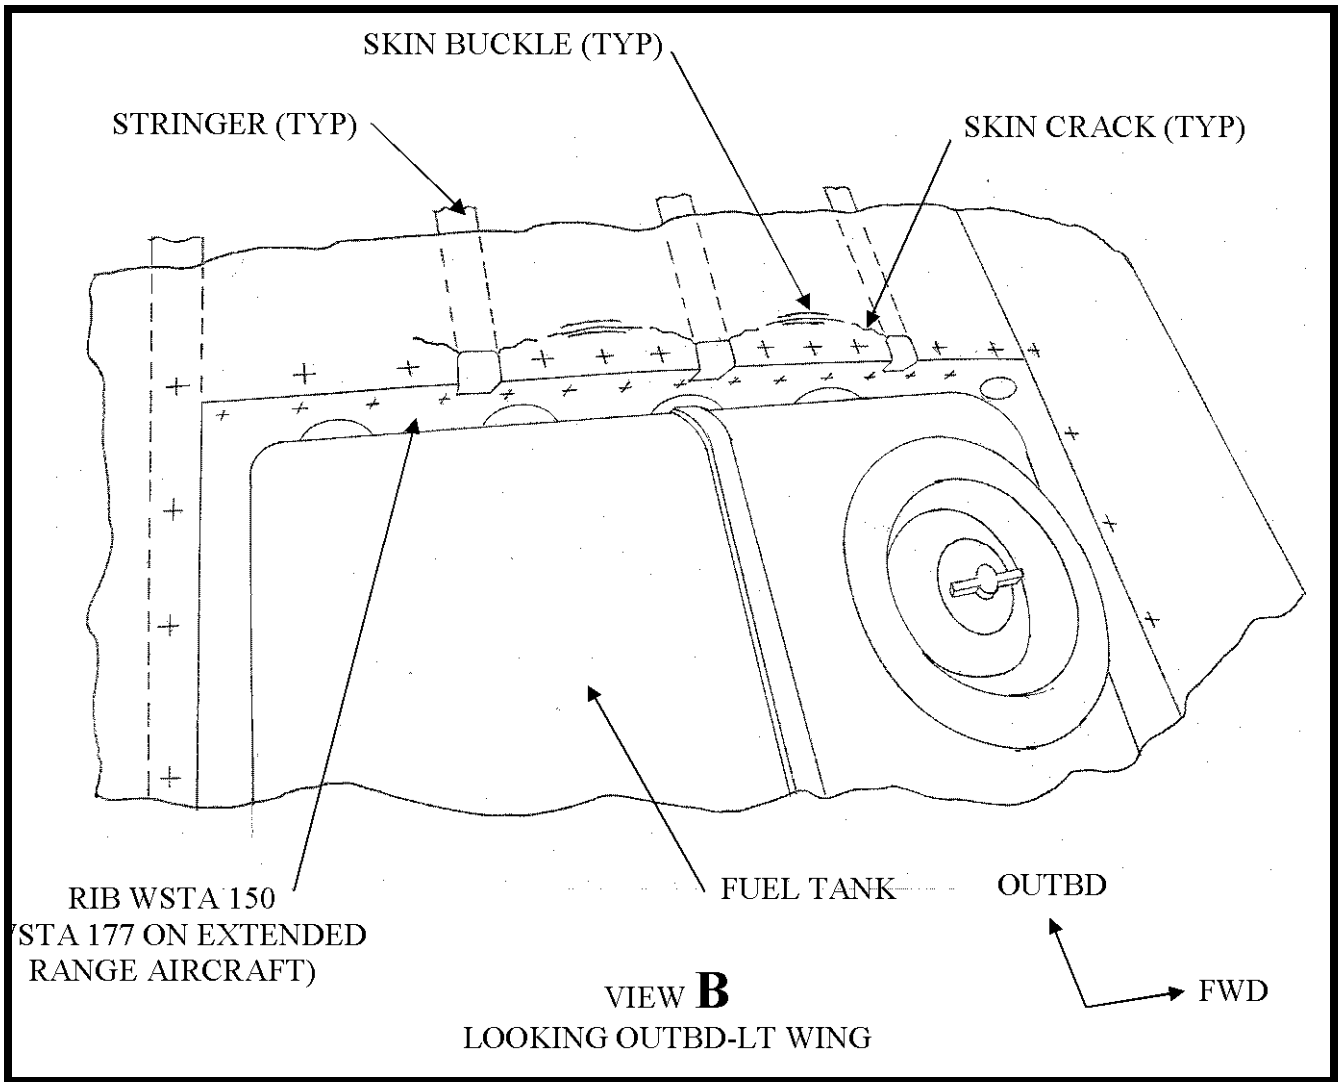
Figure 3

- (1) Wrinkles in upper wing skins, from the outboard edge on the fuel tank access covers (WSTA 150 or 177) to the WSTA 222 (See View B, Figure 3).
- (2) Wrinkles in the upper wing skins from WSTA 55 to 66, adjacent to the booms (See View E, Figure 6).

- (3) Cracking of the upper wing skins. Pay particular attention to any wrinkles, the radius between stiffeners at WSTA 150 (under fuel tank covers), and unreinforced access holes (See View B, Figure 3).

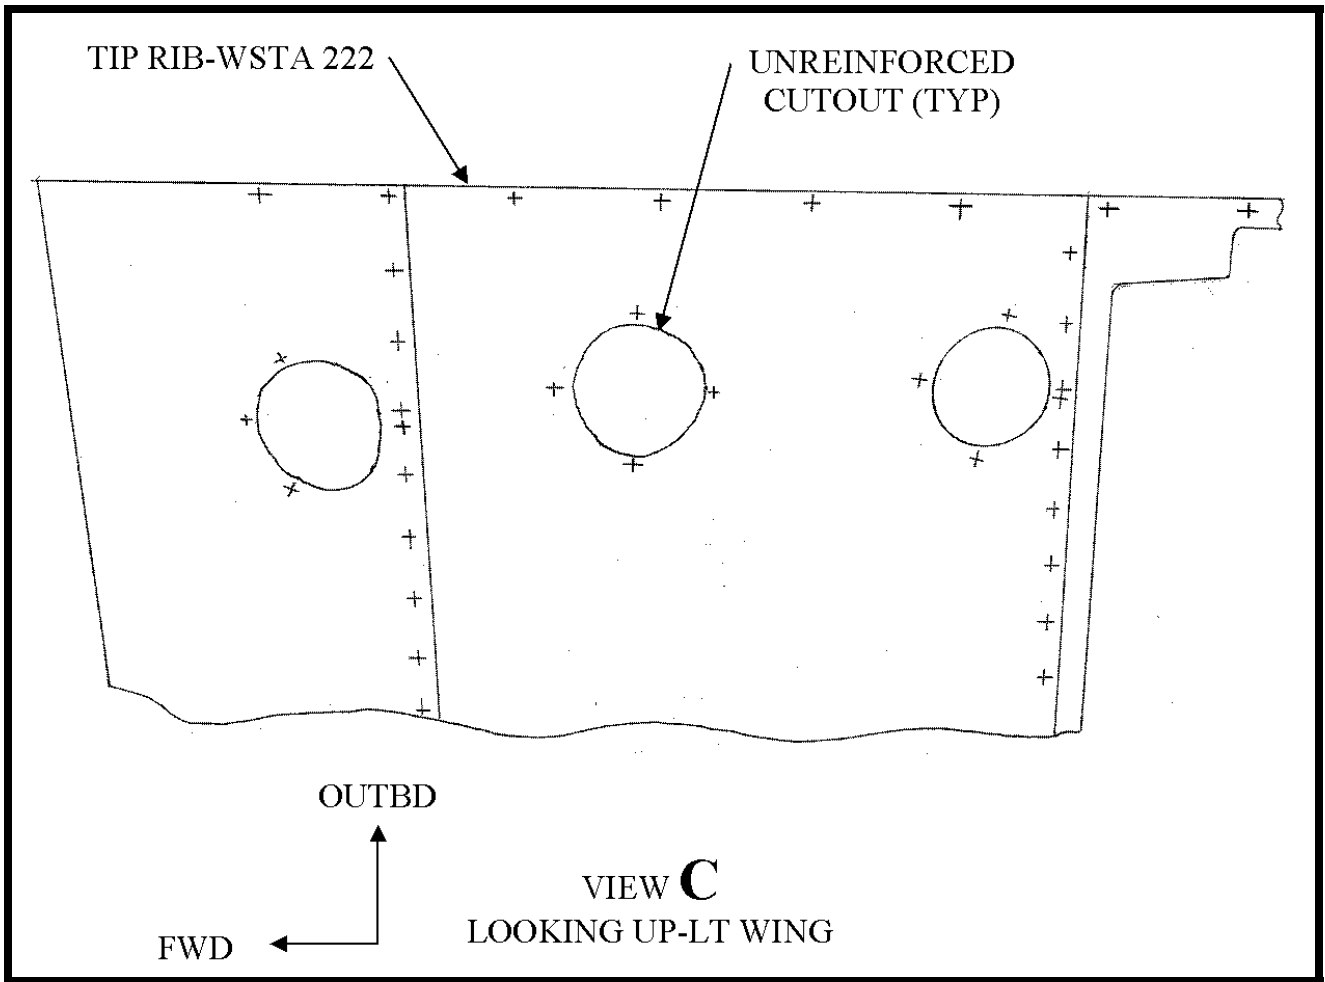
Figure 4

- (2) Inspect wing skins for unreinforced cutouts. (See View C, Figure 4).
- (3) Inspect the upper spar cap horizontal flanges for open holes (See View D, Figure 5).

| Action | Labor cost | Parts cost |
|---|---|---|
| Install reinforcements around wing access holes cutouts, 2 per hole, 6 holes per airplane | 12 work-hours X \$85 per hour = \$1,020 | \$50 |
