Airworthiness Directive

Amendment 39-3202; AD 78-09-05

Airworthiness Directives; CESSNA Models 336, 337, 337A, 337B, T337B, 337C, T337C, 337D, T337D, 337E, T337E, 337F, T337F, T337G, 337H, T337H, T337G, P337H and M337B Airplanes

To detect cracking of the wing front and rear spar lower caps, front spar web and web doubler - In accordance with instructions set forth herein and in Cessna Multi-Engine Service Letter ME78-2, dated February 13, 1978, or later revisions:

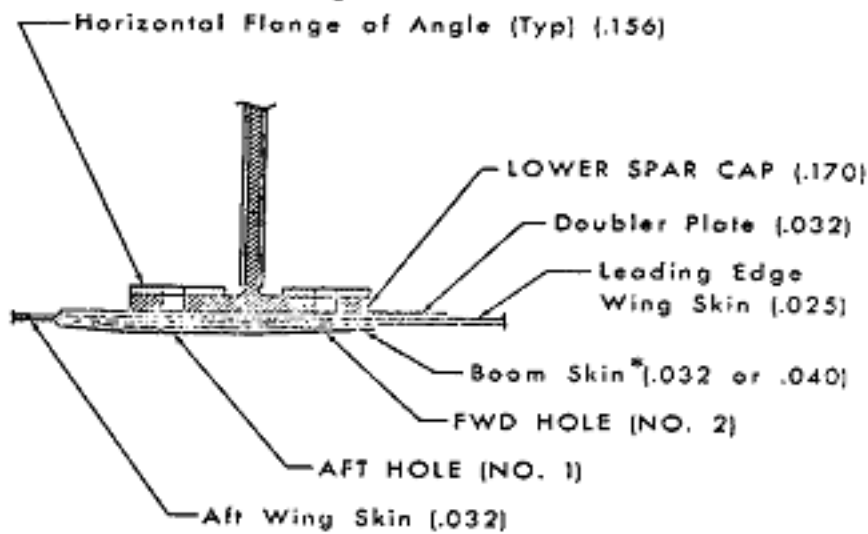
Fig. 2

b. Remove the two NAS 221 screws at Wing Station 64.41 one at a time for this inspection and hold the boom fairing firmly against underlying thicknesses of material to insure proper eddy current probe depth settings during this inspection. A cross-section with the screws at W.S. 64.41 removed is shown in Figure 2. Figure 3 shows the spar assembly (less boom and wing skins) and the relationship of the lower cap to the other parts at the strut attachment. Figure 4 shows the spar cross-section thru the jack point bolt hole.

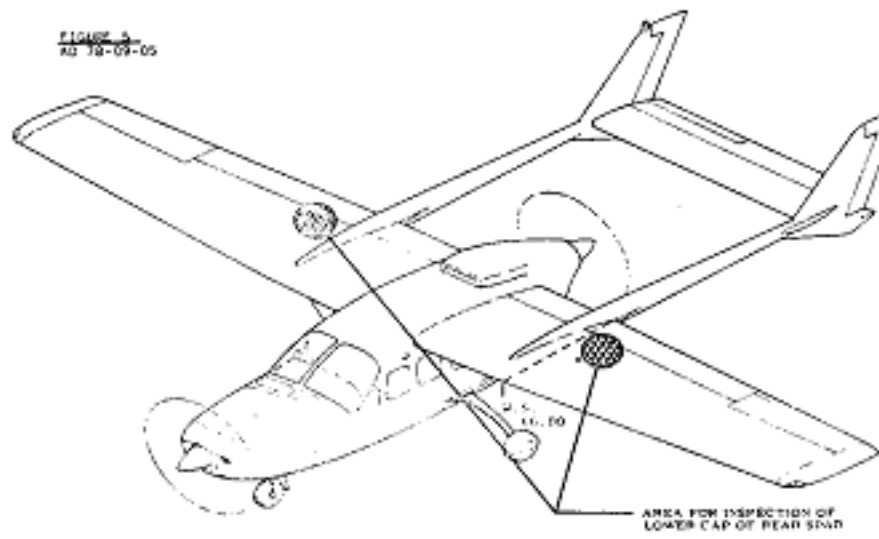
FIGURE 5
AD 78-09-05

a. Dye penetrant inspect the lower spar cap area between two and three inches (2nd rivet outboard of W.S. 66.00 rib) outboard of wing station 66.00 rib for spar cap cracks originating in the rivet hole in accordance with inspection provisions in the above noted Cessna Service Letter. Figures 5, 6 and 7 show the location of the area on the rear spar lower cap to be inspected.

b. If cracks are found in either the right or left wing rear spar lower cap during any inspection required by this AD, prior to approving the airplane for return to service replace the rear spar lower cap in both the right and left wing.

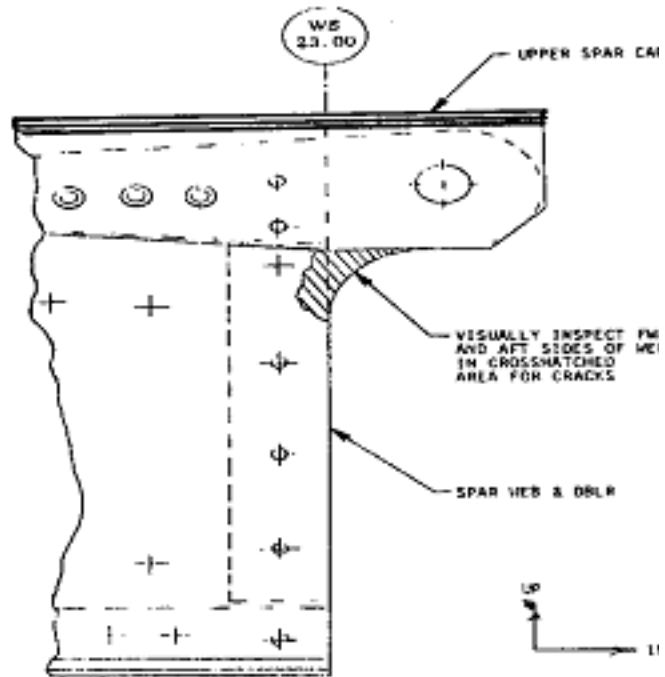
FIGURE 8 FRONT SPAR ASSEMBLY AD 78

2. Visually inspect the radii of both the spar web and web doubler for cracks in the shaded critical area shown in Figure 8 of this AD.

3. If cracks are found in either the right or left wing front spar web or web doubler during any inspection required by this AD, prior to approving the airplane for return to service, replace the discrepant components.
