[Docket No. FAA-2010-1013; Directorate Identifier 2010-CE-048-AD; Amendment 39-16478; AD 2010-21-18]

Airworthiness Directives; Cessna Aircraft Company (Cessna) Models 336, 337, 337A (USAF 02B), 337B, M337B (USAF 02A), T337B, 337C, T337C, 337D, T337D, 337E, T337E, 337F, T337F, 337G, T337G, 337H, P337H, T337H, T337H-SP, F337E, FT337E, F337F, FT337F, F337G, FT337GP, F337H, and FT337HP Airplanes

2010-21-18 Cessna Aircraft Company: Amendment 39-16478; Docket No. FAA-2010-1013; Directorate Identifier 2010-CE-048-AD.

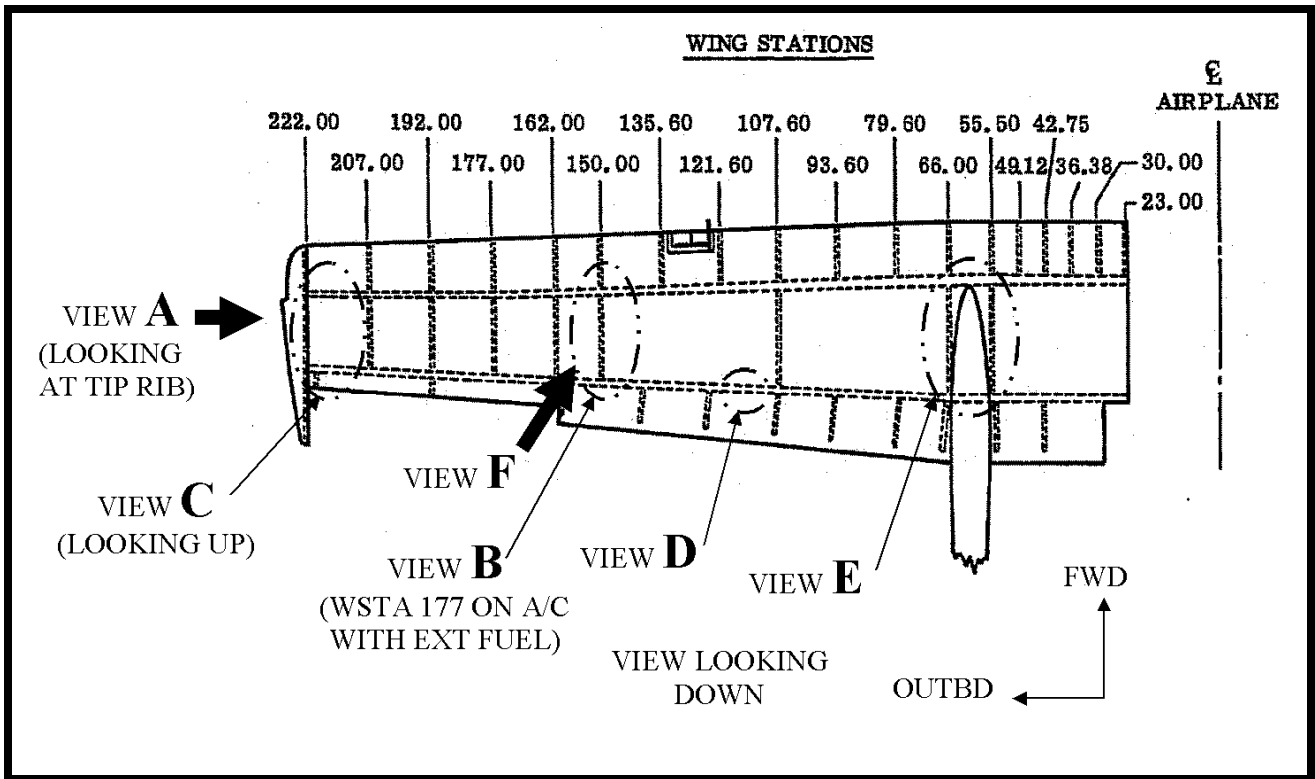
Figure 1

Perform a general and focused inspection of the wing for internal and external damage from wing station (WSTA) 23 to the wing tip. The general inspection must be performed in accordance with 14 CFR 43.15(c), using a checklist that includes at least the scope and detail of the items contained in Appendix D of 14 CFR part 43. The focused inspection must include the items listed below. Remove all wing access panels to conduct the inspections. Do these inspections following the manufacturer's service information (Cessna Maintenance/Service Manuals) and any other appropriate guidance, such as FAA Advisory Circular (AC) 43.13-1B Acceptable Methods, Techniques, and Practices—Aircraft Inspection and Repair. AC 43.13-1B can be found at <http://rgl.faa.gov/>.
