Airworthiness Directive

Amendment 39-3202; AD 78-09-05

Airworthiness Directives; CESSNA Models 336, 337, 337A, 337B, T337B, 337C, T337C, 337D, T337D, 337E, T337E, 337F, T337F, T337G, 337H, T337H, T337G, P337H and M337B Airplanes

To detect cracking of the wing front and rear spar lower caps, front spar web and web doubler - In accordance with instructions set forth herein and in Cessna Multi-Engine Service Letter ME78-2, dated February 13, 1978, or later revisions:

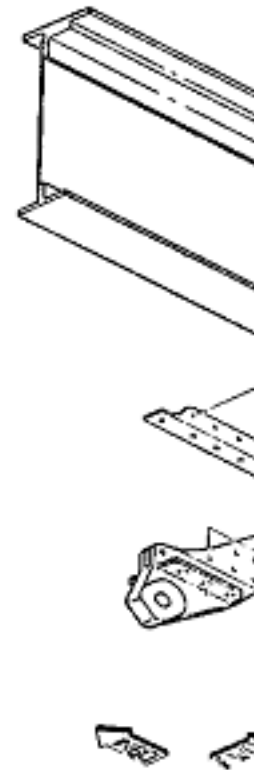
Fig. 2

a. Inspect three fastener holes on the left wing and three fastener holes on the right wing for wing spar cracks using eddy current inspection procedures outlined in the above noted Cessna Service Letter. Figure 1 shows the area involved and the three fasteners (two NAS 221 screws at W.S. 64.41 and the jack point bolt hole at W.S. 68.45) that are to be inspected.

b. Remove the two NAS 221 screws at Wing Station 64.41 one at a time for this inspection and hold the boom fairing firmly against underlying thicknesses of material to insure proper eddy current probe depth settings during this inspection. A cross-section with the screws at W.S. 64.41 removed is shown in Figure 2. Figure 3 shows the spar assembly (less boom and wing skins) and the relationship of the lower cap to the other parts at the strut attachment. Figure 4 shows the spar cross-section thru the jack point bolt hole.

c. If cracks are found in either the right or left wing front spar lower cap during any inspection required by this AD, prior to approving the airplane for return to service replace the front spar lower cap in both the right and left wing with new spar caps.
