THE C-336 SKYMASTER STORY

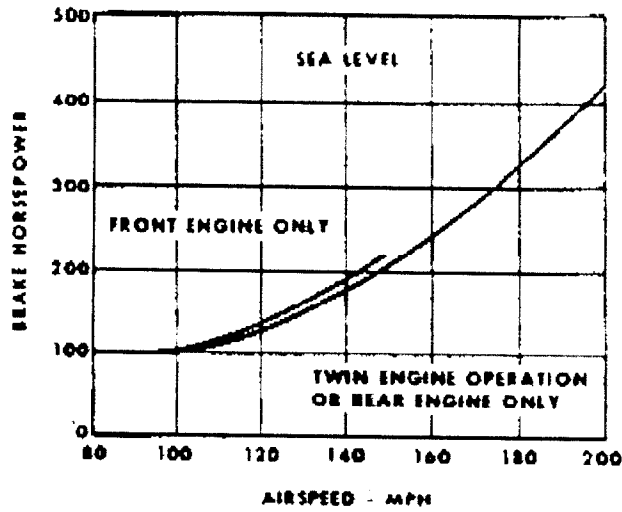
Fig. 10 - Effect of front or rear engine operation on speed-power
